### Eliminating Audio Hum

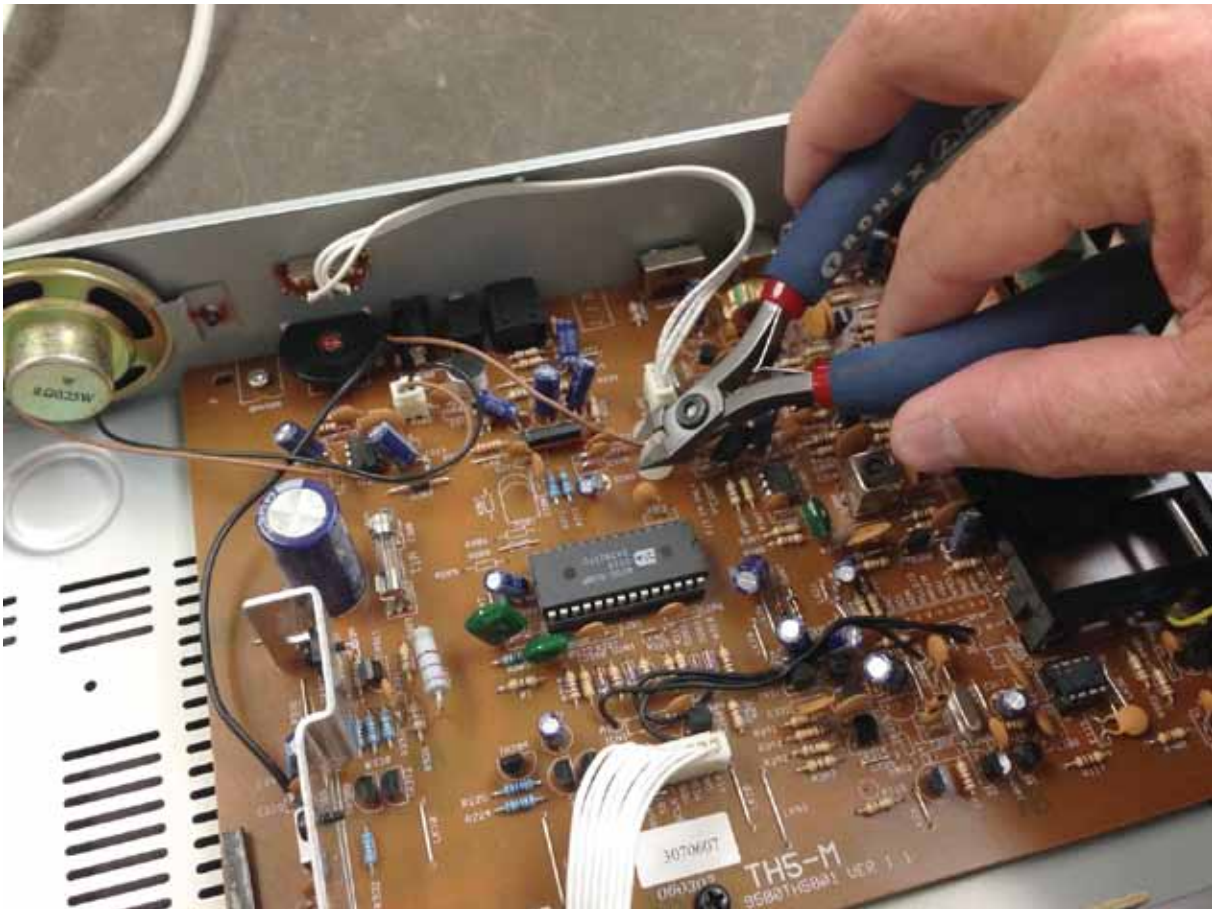
2. Open the unit by removing 4 Phillips Head screws in cover and cut away the internal brown ground wire as illustrated.

If an audio hum (60 cycle noise) is apparent on the radio, one or both of the following may lower the noise level.

1. Disconnect the 3rd ground prong from the power supply as plugged into the wall. Use of a 3 prong to 2 prong adapter is recommended. Note: Disconnecting the ground may effect coverage and broadcast range so this should be retested.
